Contract #: 04-0120F4Cty: SF/ALA Rte: 80 PM: 13.2/13.9File #: 69.28**WELDING INSPECTION REPORT****Resident Engineer:**Siegenthaler, Peter**Address:** 333 Burma Road**City:** Oakland, CA 94607**Report No:** WIR-017502**Date Inspected:** 03-Oct-2010**Project Name:** SAS Superstructure**OSM Arrival Time:** 700**Prime Contractor:** American Bridge/Fluor Enterprises, a JV**OSM Departure Time:** 1900**Contractor:** Zhenhua Port Machinery Company, Ltd (ZPMC), Changxing Island **Location:** Shanghai, China

Bridge No: 34-0006**Component:** Tower**Summary of Items Observed:**

Heavy Dock #Tower Trial assembly

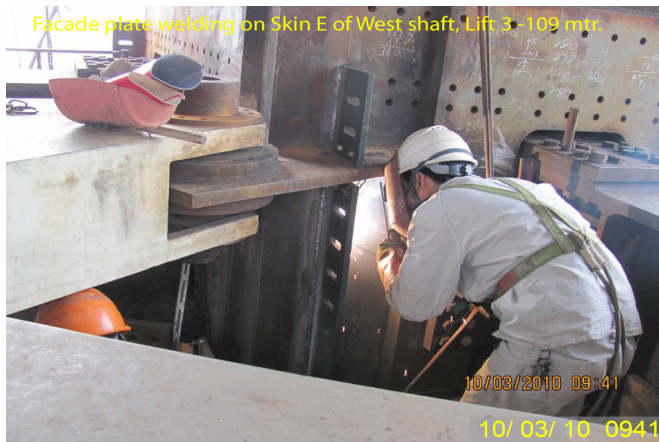
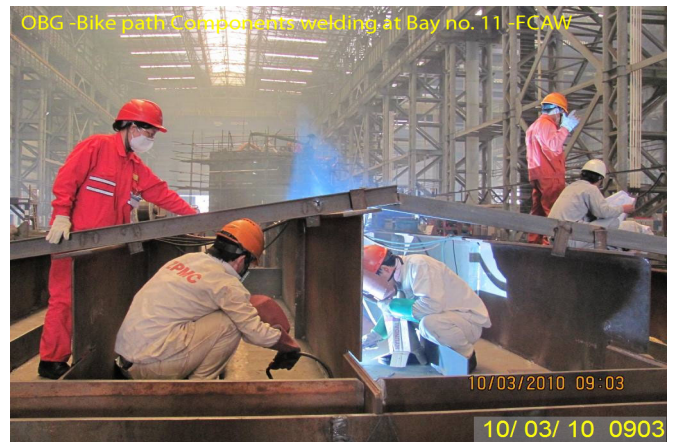
For further information see below pictures:-

Unless otherwise noted, all work observed on this date appeared to be in general compliance with the applicable contract documents.
